Sullivan Mine Fatalities Technical Investigation and Subsequent Risk Management Monitoring

Abstract

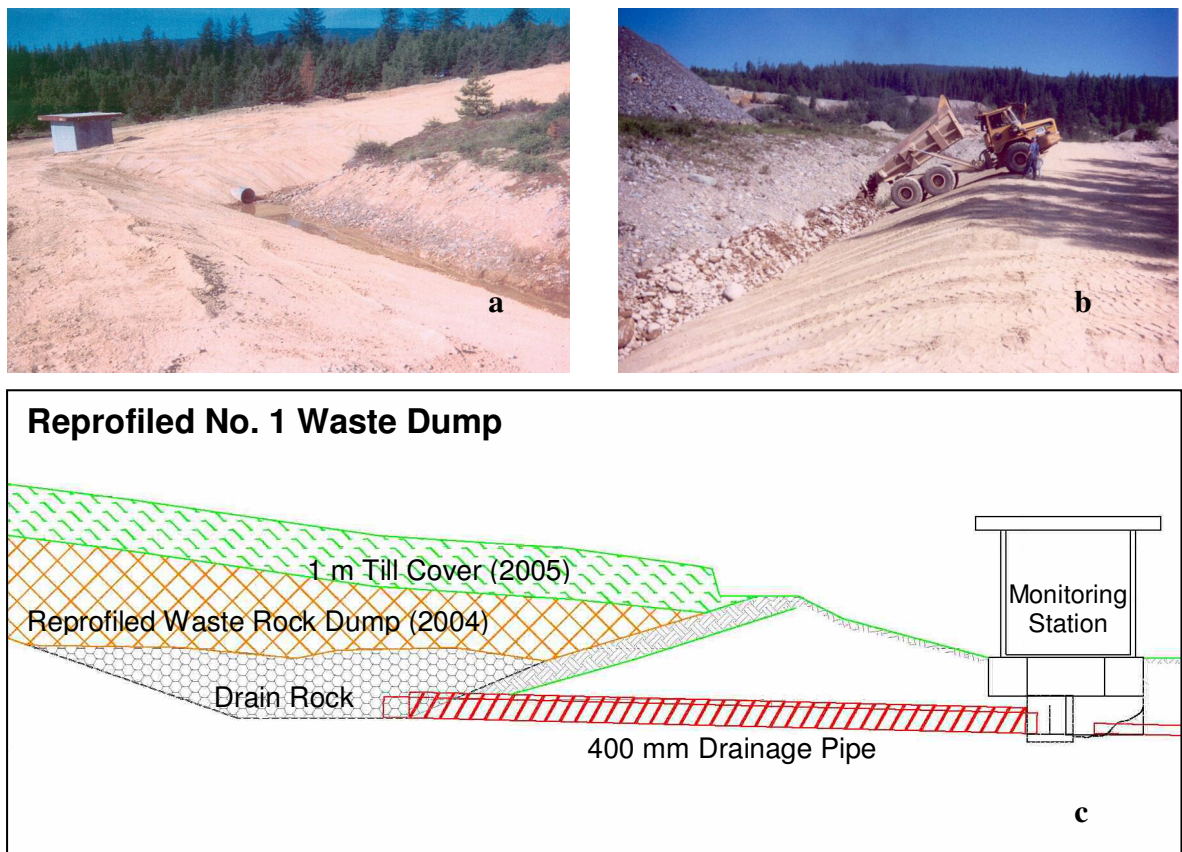
To reduce impacts of WD1 drainage on the downgradient Lois Creek, a toe ditch was installed in the early 1990s. The ditch intercepted gravel lenses that hosted shallow seepage and was instrumental in the recovery of Lois Creek water quality. To retain the function of the ditch, reclamation plans required the ditch to be converted to a toe drain. Coarse drain rock was placed in the ditch and the dump was reprofiled in 2004. In 2005 a 1 m till cover was placed over the dump (see Figure 1). Such a design was not without precedent at the site, as the near-by North Dump in the Lower Mine Yard had been reclaimed in the mid-1990s using similar methods.

Figure 1. The Monitoring Station and toe ditch confluence prior to reclamation (a). Drain rock being placed in the toe ditch (b). Cross-section showing drain rock, waste rock and till cover in former ditch with 400 mm diameter drainage pipe conveying seepage to Monitoring Station (c).

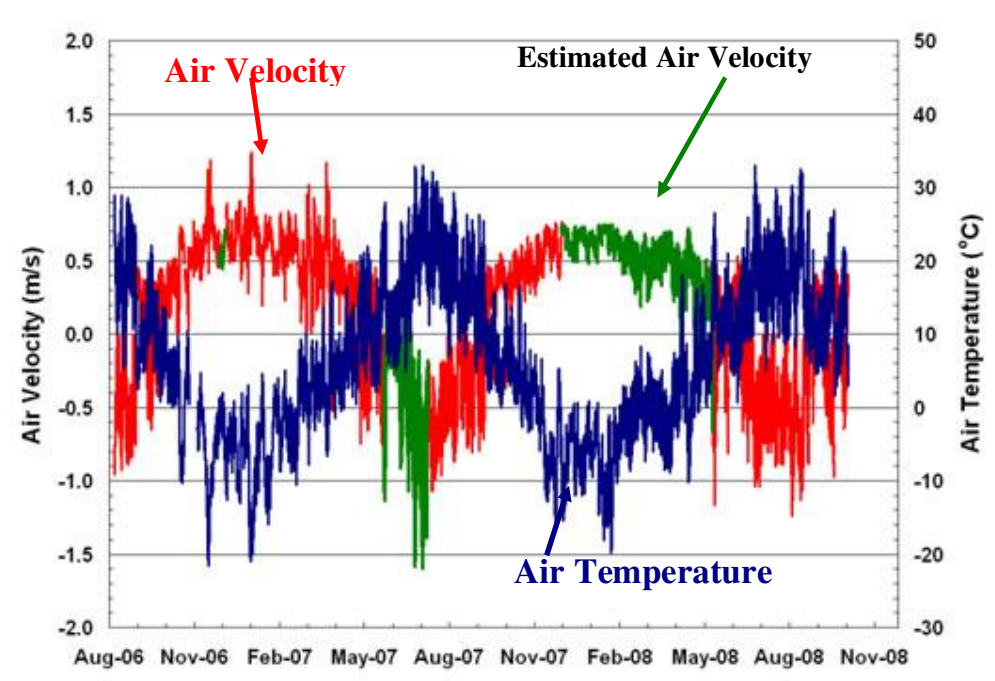
Results show a clear relationship between air velocity in the 400 mm pipe at the Monitoring Station and atmospheric air temperature. Air movement in and out of the dump is herein termed “respiration”. Air temperature controls respiration by affecting the relative density of the interior pore gases compared with external ambient air. The internal temperature of the dump remains fairly constant throughout the year while the external air temperature is much warmer in the summer and much cooler in the winter. From fall to spring, the internal pore gas is warmer and thus less dense than the surrounding external atmosphere, and rises up through the dump and exits through the cover, pulling cooler ambient air into the toe and lower slope of the dump. Some of this in-flowing air was drawn in through the 400 mm pipe. During the summer the opposite condition exists, causing some pore gas to flow out of the dump through the 400 mm pipe. A comparison of atmospheric air temperature and air velocity reveals a strong relationship (see Figure 2). The air flow through the 400 mm pipe is designated as a positive velocity if the flow is into the pipe and toe drain; negative if out of the pipe and into the Monitoring Station. A “pivot point” of about 10-12°C is evident, and represents the air temperature at which airflow in the 400 mm pipe changes direction.

Figure 2 Time series comparison of air temperature and air velocity

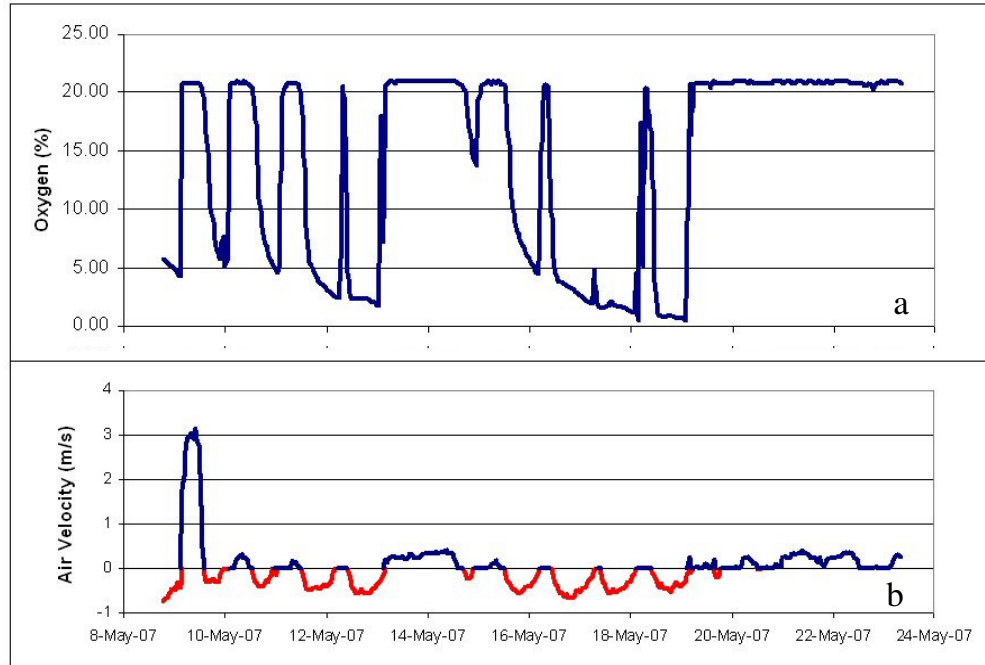
Movement of air into and out of the dump through the 400 mm pipe was very dynamic. Air velocity values and automated gas composition readings correspond well and indicate how quickly conditions in the Monitoring Station became hazardous (see Figure 3).

Figure 3. Changes in Monitoring Station oxygen concentration (a) in response to 400 mm pipe air velocity (b). Positive air velocity (blue) represents air flowing into the dump; negative air velocity (red) represents pore gas flowing out of the dump.

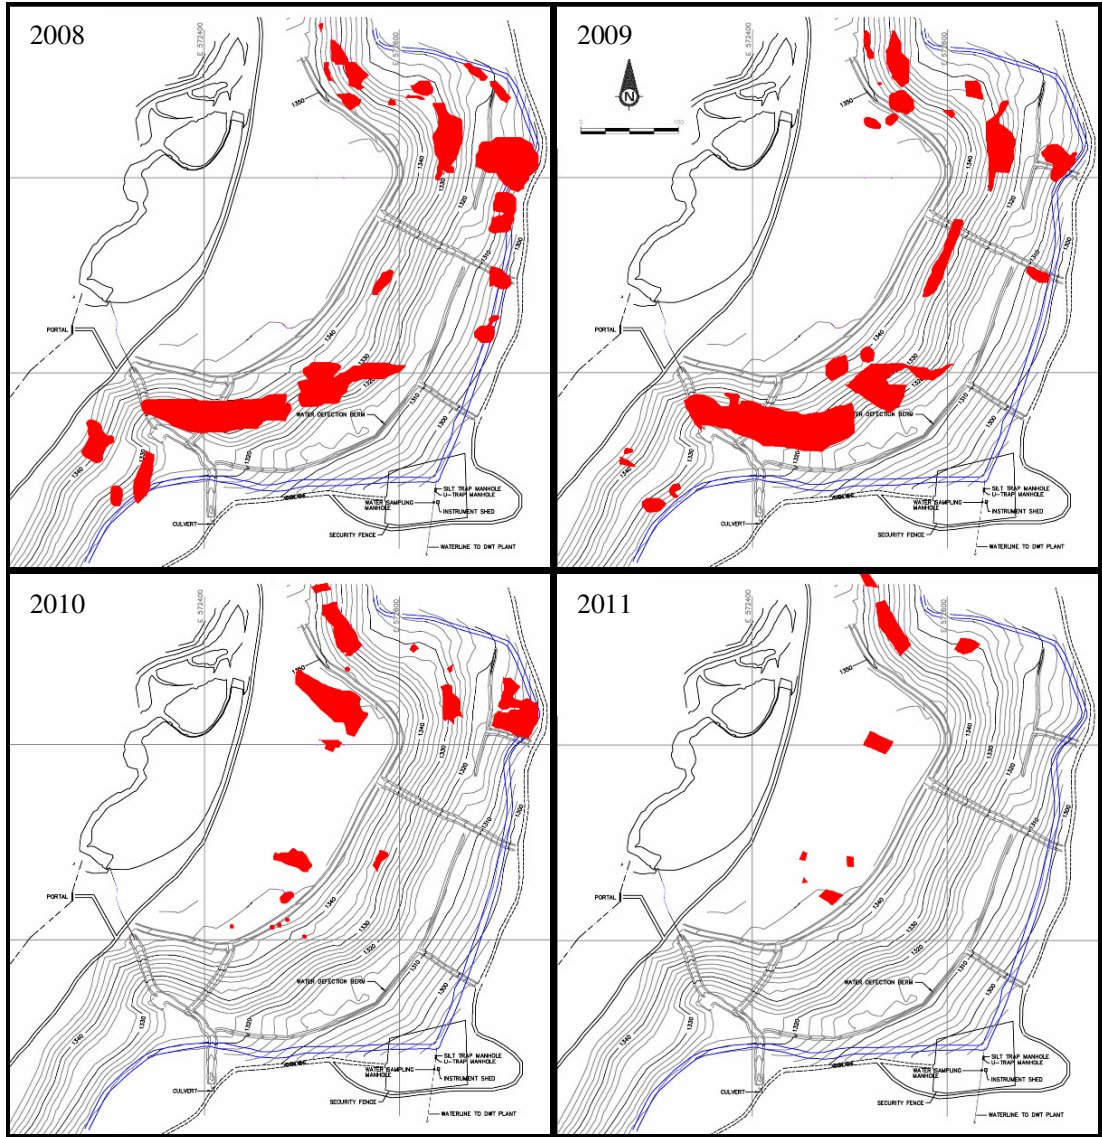
Site monitoring in February and March of 2010 and 2011 showed reduced PSA sizes. Figure 4 shows the greatest extent of recorded PSA for the years 2008 to 2011. Monitoring for pore gas at the surface was conducted in the PSAs, and pore gas was not detected in 2010 or 2011 when using the same equipment and techniques applied in previous years. PSAs were greatly reduced in 2011, but this may potentially be indicative of a very large winter snow pack. PSA monitoring will continue in 2012.

Figure 4. The greatest extent of PSAs in February and March of 2008, 2009, 2010 and 2011.

Additional till cover material was placed to obtain the design thickness of 1.0 m in late August 2009 at the three areas with insufficient cover thickness. Multiple gas traps were installed on the additional cover material in September 2009. Gas traps along the dump crest showed at least an order of magnitude reduction in pore gas flux through the cover compared to fluxes at similar temperatures prior to the cover repairs. The order of magnitude reduction in pore gas flux has been maintained. Pore gas effects can no longer be detected at several of the gas traps.

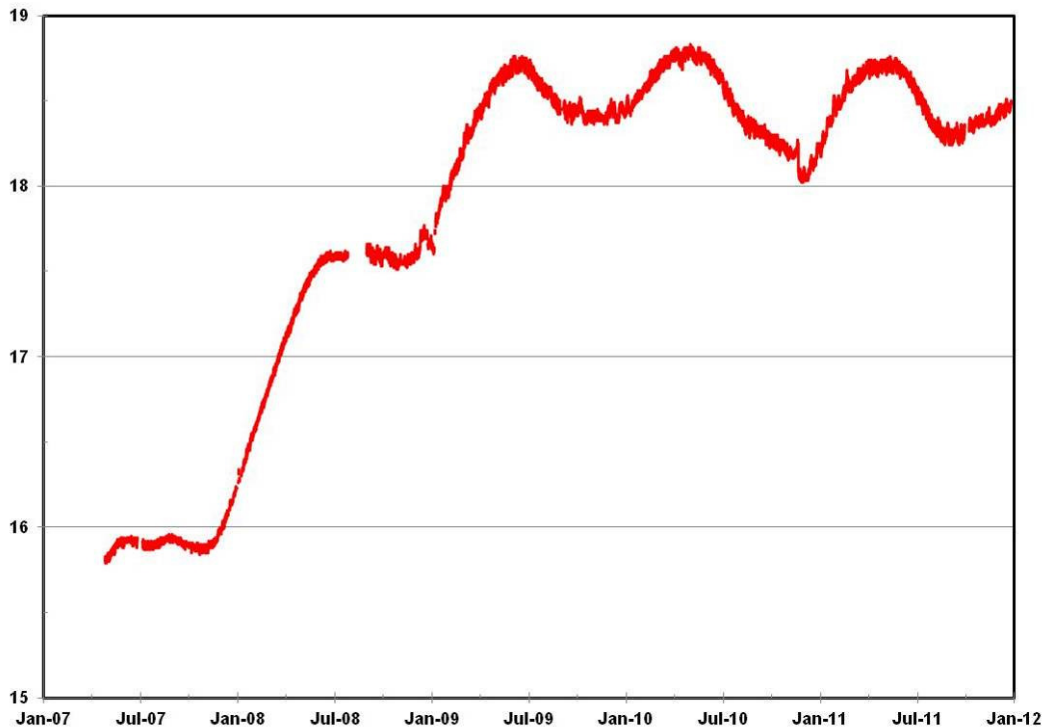
The *in situ* core temperature appears to have stabilized after increasing during the period of the technical investigation. Borehole 1A (BH-1A) is located on the top surface and at one of the thickest portions of WD1. The upper and lower portions of BH-1A are influenced by atmospheric and natural ground temperature, respectively, but the middle of BH-1A maintains a core temperature that was utilized as a reference point for WD1 (see Figure 5). The increase in temperature is believed to be caused by heat retention due to cover placement in 2005. Many borehole or push-in locations along the periphery of the dump continue to show temperature results that are heavily influenced by atmospheric conditions.

Figure 5. BH-1A core temperature (15 m depth).

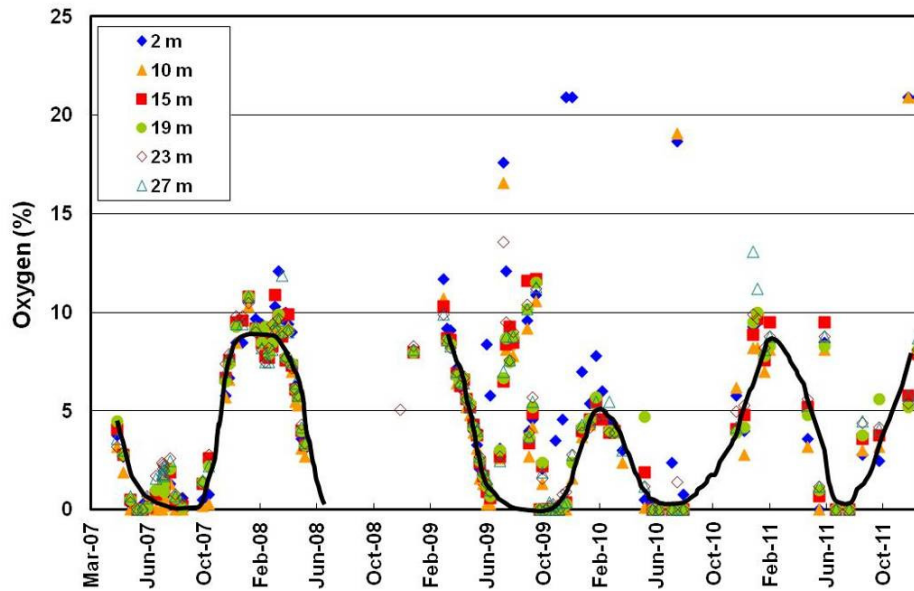
In situ pore gas composition is within the same range as found prior to cover repair. Figure 6 shows oxygen concentrations at BH-1A. Since the cover repairs in August 2009, results from individual sampling events show an increased range, but the overall seasonal pattern remains unchanged. The results from the summer of 2009 do not conform to the seasonal respiration airflow pattern, with oxygen concentrations that are expected during the winter. 2009 summer air temperatures were not unusual and cannot explain this deviation. One possible explanation is the cover characterization that was conducted at this time. Test pits were excavated to the waste rock both in and outside of PSAs, and several were on the mid-slope bench below BH-1A. Perhaps this direct contact between the atmosphere and waste rock allowed new pore gas flow paths to develop and influence results.

Figure 6 also shows the oxygen concentration during February 2010 to be less than normal. This is believed to be the result of mild air temperatures, which would have reduced pore gas flow through WD1. The average air temperature for January – March, 2010 was -0.6 °C. The average air

temperatures for the same period in 2008, 2009, and 2011 were -3.9 °C, -4.4 °C, and -4.6 °C. This example further highlights the control of airflow respiration by air temperature at the WD1.

Figure 6. Oxygen concentrations at various depths of BH-1A; the black line highlights the expected seasonal trend.
